Manhole Inspection Summary

Manhole # S45C2_026MH

Insp Date: **12/18/07 1:40 PM**

Location Address: **1160 Monroe Circle**

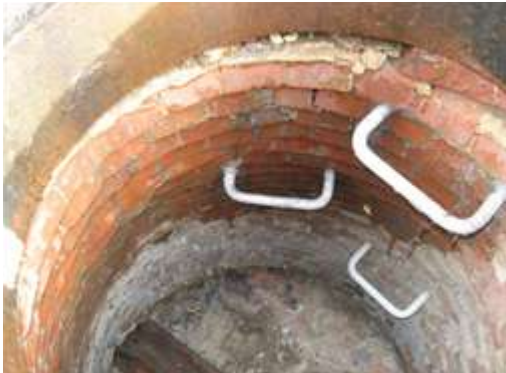
Defect 1

Condition: ☐ Sound ☐ Cracked ☐ Root Intrusion ☒ **Loose Brick** ☐ Deteriorated

Loose bricks

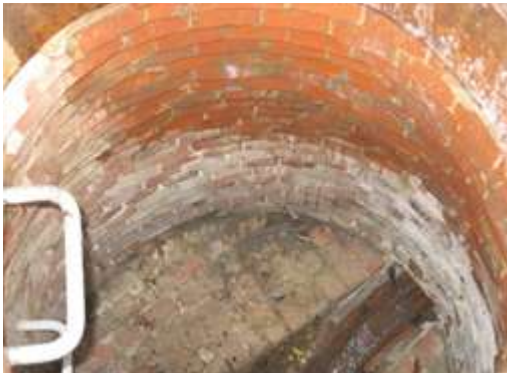
Defect 2

Infiltration: ☐ None ☐ Joint ☐ Cracks ☐ Mortar ☐ Roots ☒ **Wall**

Wall

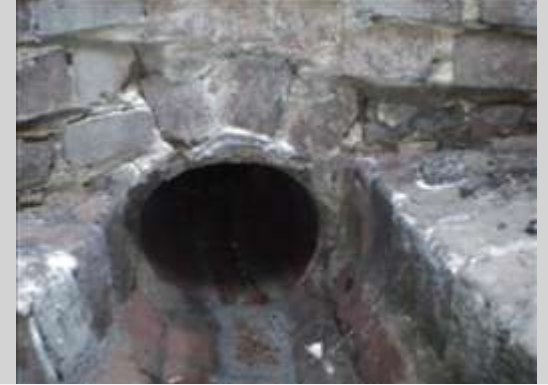
12 O'Clock Outflow

8 in. Circular Gravity Sewer
Pipe Out @ 12 O'Clock

Pipe Height: **8.4** (in.) Rod and Bar (Angled)
Pipe Material: **Clay** ☐ Pipe Lined
Invert Depth: **6.69** (ft.) Flow Characteristics: **Fast**
Deposits: ☒ None ☐ Mud ☐ Sludge ☐ Debris ☐ Grease
Silt Depth: (in.) Deposits Extent:
Infiltration: **None** Pipe Seal Cond: **Sound**

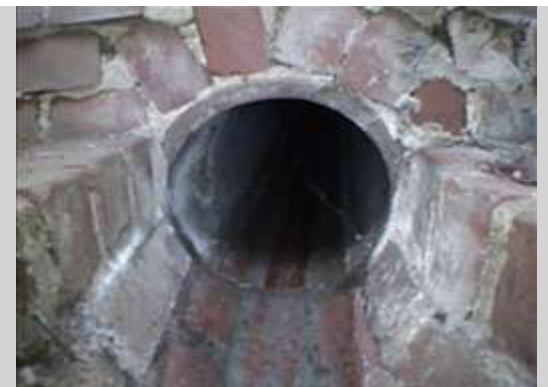
9 O'Clock Inflow

8 in. Circular Gravity Sewer
Pipe In @ 9 O'Clock

Pipe Height: **8.4** (in.) Rod and Bar (Angled)
Pipe Material: **Clay** ☐ Pipe Lined
Invert Depth: **6.50** (ft.) Flow Characteristics: **Fast**
Deposits: ☒ None ☐ Mud ☐ Sludge ☐ Debris ☐ Grease
Silt Depth: (in.) Deposits Extent:
Infiltration: **None** Pipe Seal Cond: **Sound**
